EnviroStraw & EnviroMatrix Case Study (BHP Billiton) South Walker Creek Mine Site Rehabilitation

- Prepared by: Hercules Strydom, Agronomist (Specialising in Biological Farming Enterprises)
 - Date: October-December 2015
 - Project: 50-hectare rehabilitation program on the South Walker Creek mine site.
 - Background: During this period the site received no significant rain events, with the exception of one 5 – 10 mm rain event on the southern section of the project. From that single rain event, some seed germination was experienced and some water pooling occurred from overland flow (which was sufficient to moisten the soil). Average daily temperatures were 35 to 40 degrees C.
- * Please see separately attached typical soil analysis report of the different areas that needed rehabilitation.

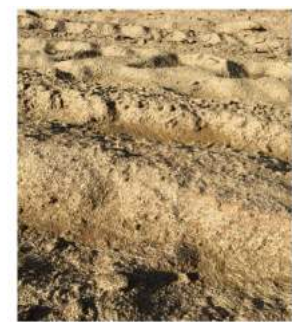
↑ Sloped areas were hydromulched at various stages and showed signs of water pooling

Some germination was observed in pooled areas with less than a 10mm rain event.

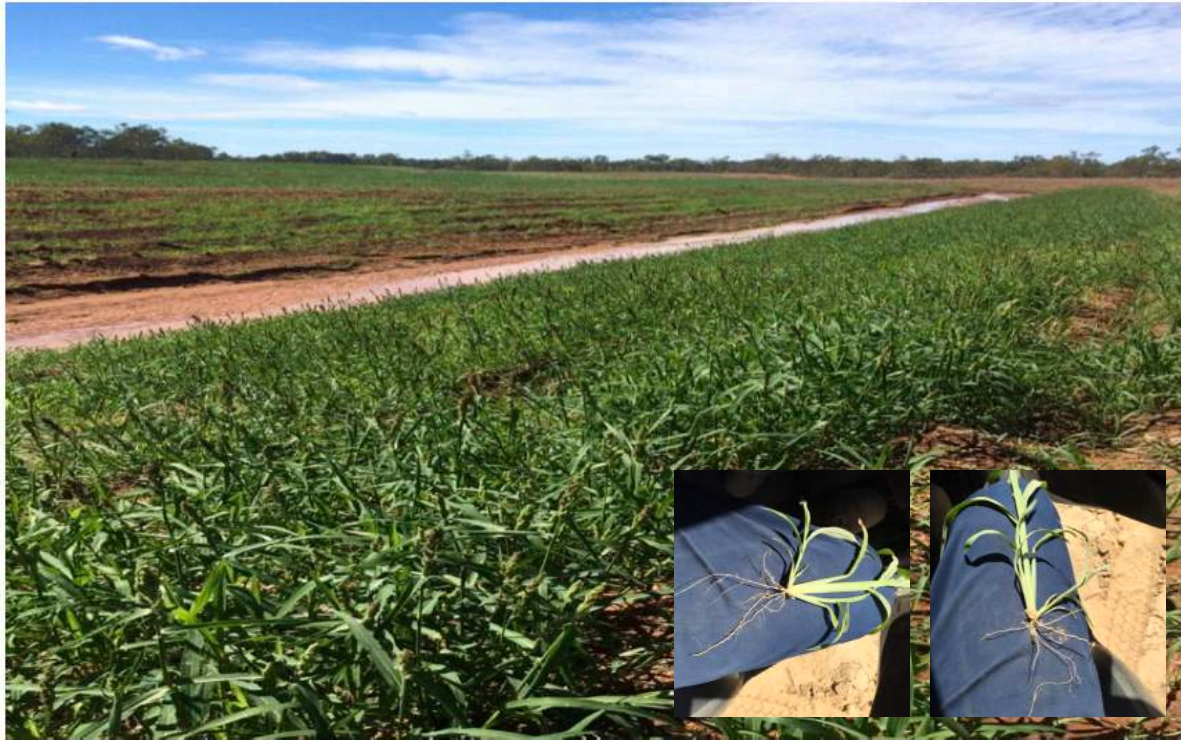
↑ Cover crop growth 5 – 6 weeks after 50 – 70 mm of rain.

The mine site environmental officers were surprised by the successful germination and growth after the initial major rain event. They commented that it is one of the best results they have witnessed when compared to other projects on this site.

Nearly all plants that germinated went to seed without yellowing or premature seed setting, in comparison to all other previous revegetation projects.

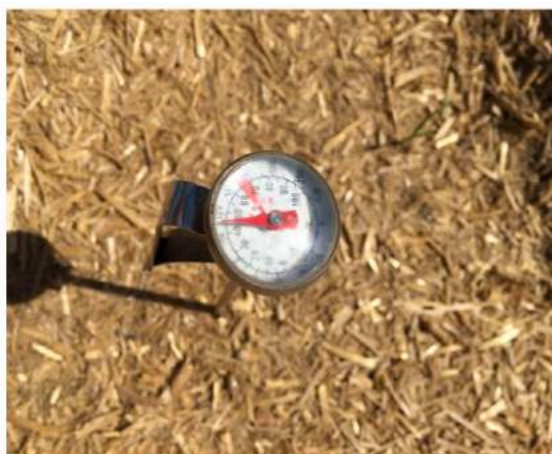
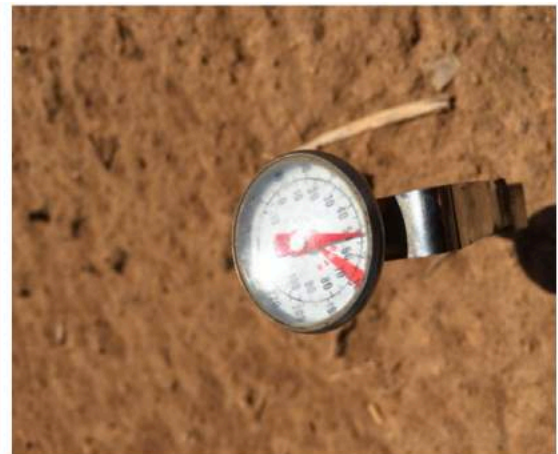
↑ Treated Temperature reading, left, 45 degrees, and untreated temperature reading, right, 50+ degrees.

Soil surface temperature measurement comparisons: treated versus untreated
